# Arboricultural Survey Report 2025

Borden Nature Reserve, Borden Lane, Borden Kent

**Report Ref:** AS0308/05-25

**Report Date:** 15<sup>th</sup> May 2025

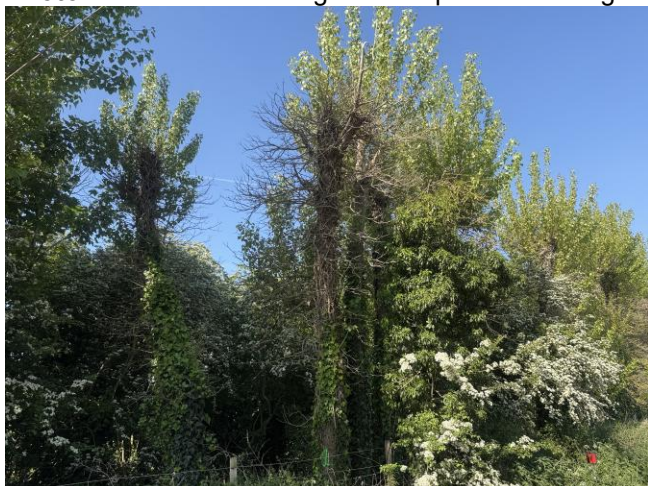
Photo 1 – View of standing dead Poplar T1 within group G1 (Please refer to tree location plan at Appendix B)
